Subject: City of Haverhill, MA NPDES Permit #MA 0101621  
Consent Decree Submittal (Civil Action No. 16-11698-IT)  
Compliance Report Number 9 – July 1, 2020 through December 31, 2020

CITY OF HAVERHILL, MASSACHUSETTS

COMPLIANCE REPORT No. 9

JULY THROUGH DECEMBER 2020

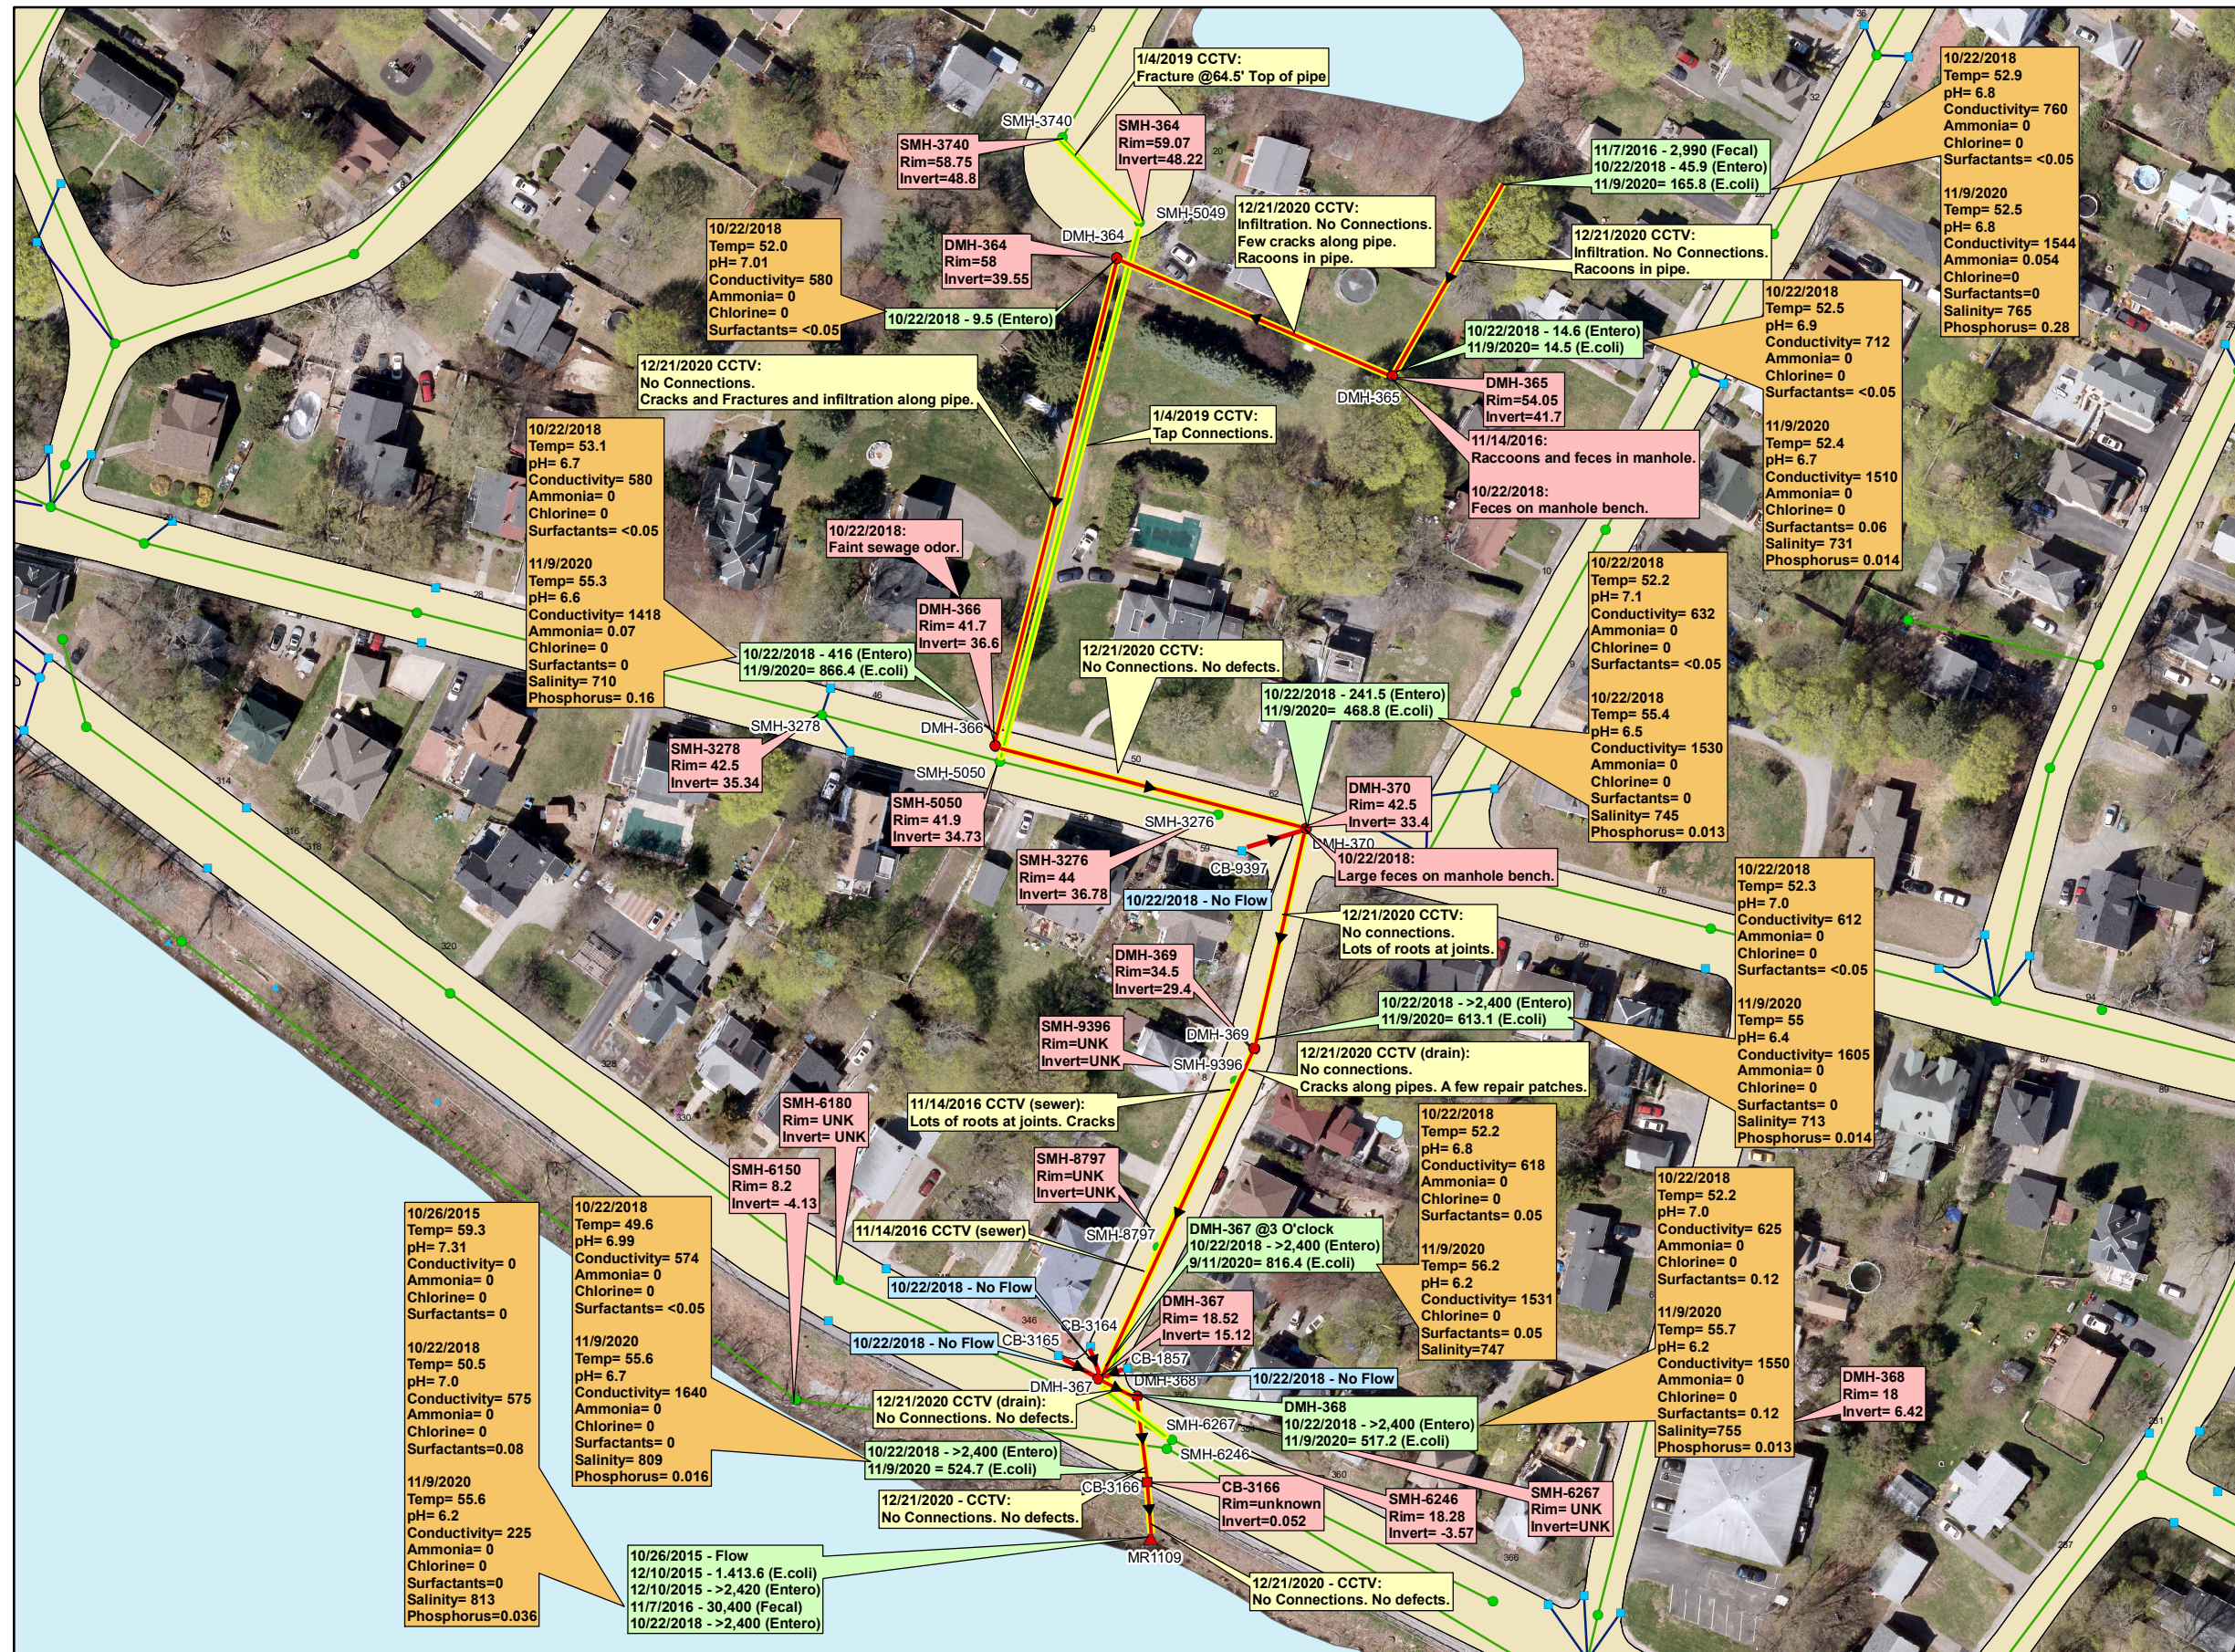
# Outfall MR1109

MR1109 was inspected and sampled on 11/9/2020 including the full catchment area, flow was detected and traced to the inlet for the catchment area. This inlet is placed at a depression area to relieve groundwater and avoid water runoff entering homes. CCTV was completed of the drainage with no additional infiltration sources found. The City will conduct CCTV of the surrounding sewer connections to ensure no infiltration. CCTV revealed raccoons living in the catchment area resulting in high bacteria counts. Additional lab testing will be required for bacteria counts.

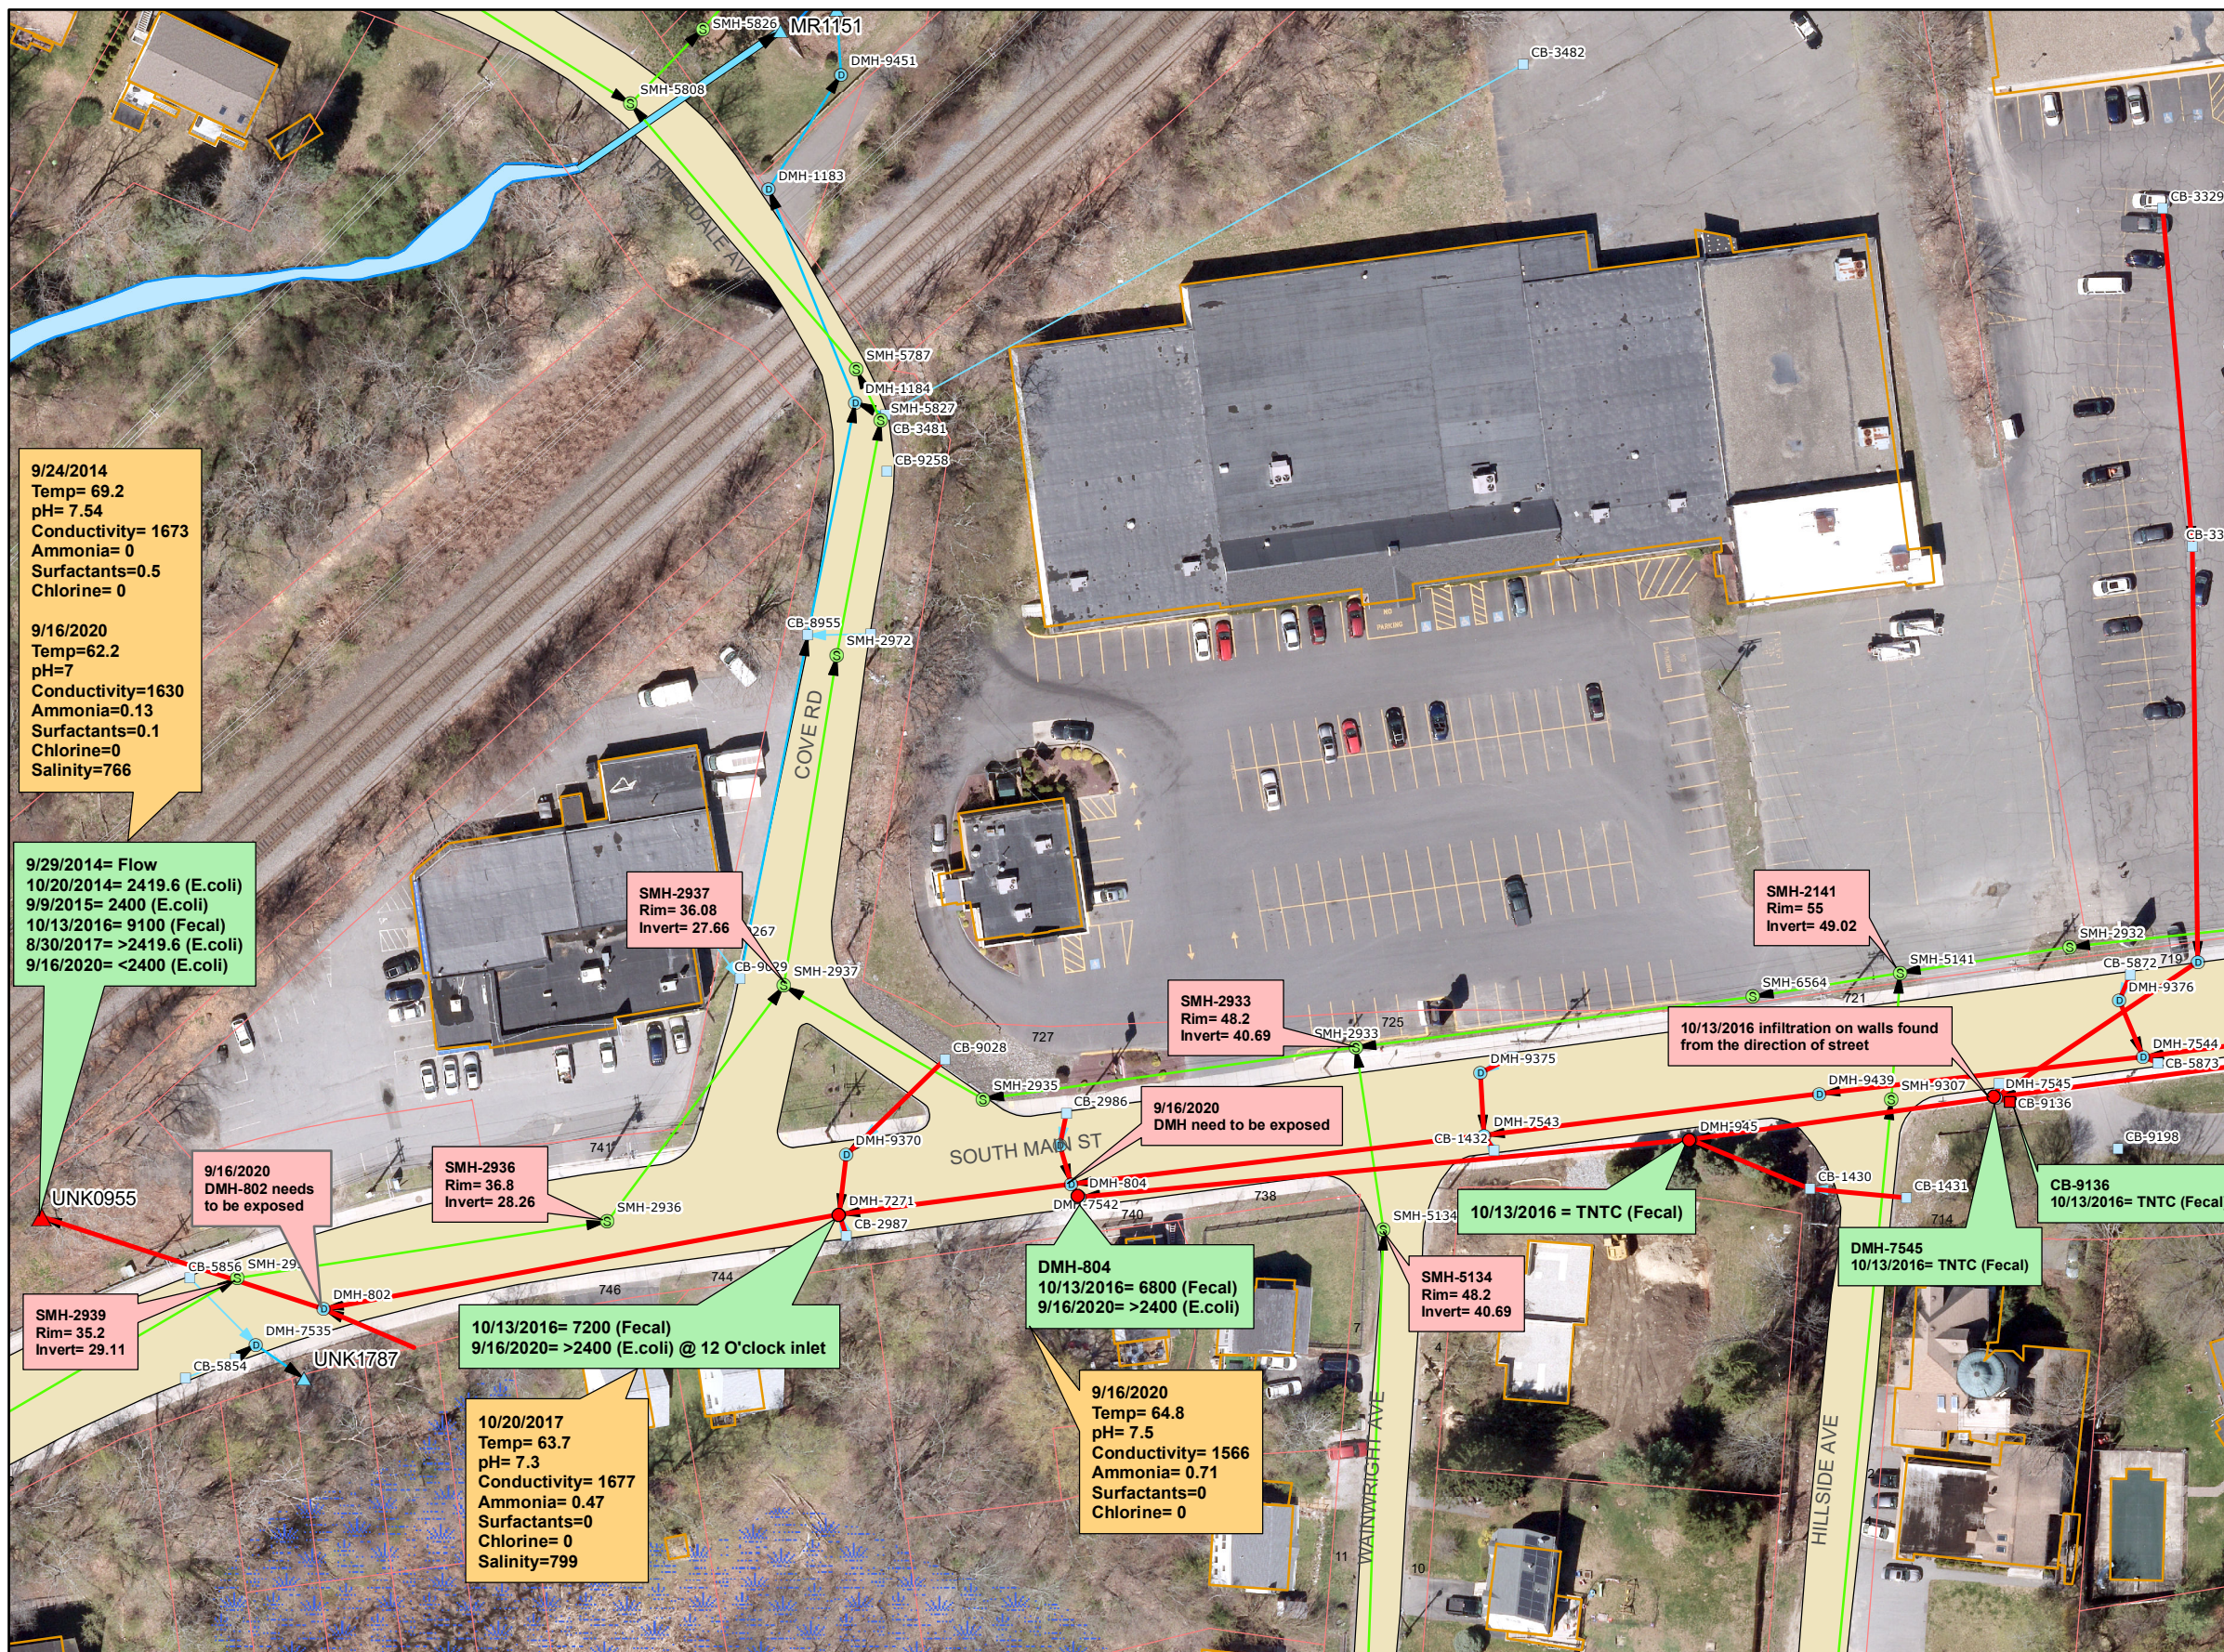
# Outfall UNK0955

UNK0955 – was inspected and sampled on 9/16/2020 and the catchment area was inspected and found that there are drain manholes that have been paved over that are driving flow to the outfall. These drain manholes will be exposed and CCTV'd when weather permits to identify source of illicit flow.
