Subject: City of Haverhill, MA NPDES Permit #MA 0101621  
Consent Decree Submittal (Civil Action No. 16-11698-IT)  
Compliance Report Number 9 – July 1, 2020 through December 31, 2020

CITY OF HAVERHILL, MASSACHUSETTS

COMPLIANCE REPORT No. 9

JULY THROUGH DECEMBER 2020

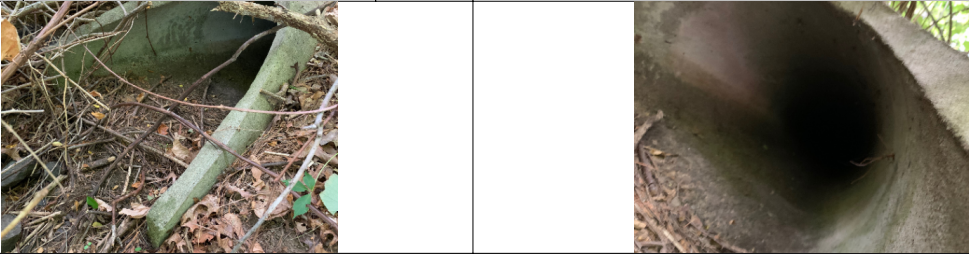
| SECTION 1: BACKGROUND DATA | | | | | | | | | |
|---|--|---|--|--|---|--|--|--|--|
| Street Name/Structure Location: Cross Country | | | | | | | | | |

| SECTION 3: OUTFALL PIPE PHYSICAL INDICATORS | | | |
|---|---|---|---|
| Asset Damage | None | | |
| Deposits/Stains | Flow Line | | |

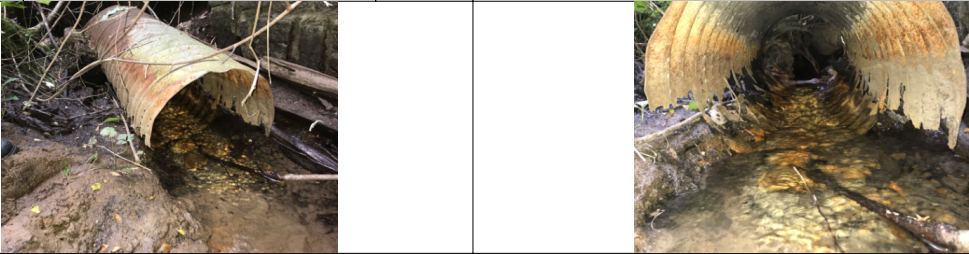
| SECTION 1: BACKGROUND DATA | | | | | | | | | |
|---|--|---|--|--|---|--|--|--|--|
| Street Name/Structure Location: NEWARK ST | | | | | | | | | |

| SECTION 3: OUTFALL PIPE PHYSICAL INDICATORS | | | | |
|---|---|---|---|---|
| Asset Damage | Chipping/Corrosion | | | |
| Deposits/Stains | Flow Line | | | |

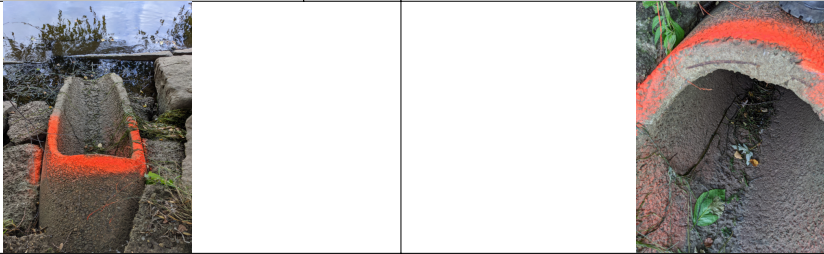
| SECTION 1: BACKGROUND DATA | | | | | | | | | |
|---|--|---|--|--|---|--|---|--|--|
| Street Name/Structure Location: | | MERIMACK RIVER | | | | | | | |

| SECTION 3: OUTFALL PIPE PHYSICAL INDICATORS | | | |
|---|---|---|---|
| Asset Damage | Chipping/Corrosion | | |
| Deposits/Stains | Flow Line | | |

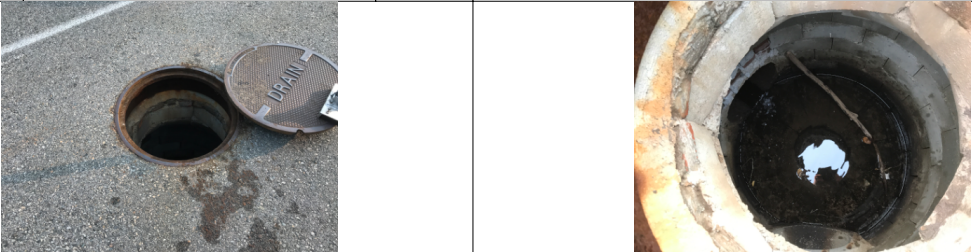
| SECTION 1: BACKGROUND DATA | | | | |
|---|---|--|---|---|
| Street Name/Structure Location: | SOUTH MAIN ST | | | |

| SECTION 3A: INLET PIPE NO. 1 PHYSICAL INDICATORS | | | | | |
|---|---|---|--|---|---|
| Asset Damage | None | | | | |
| Deposits/Stains | Flow Line | | | | |

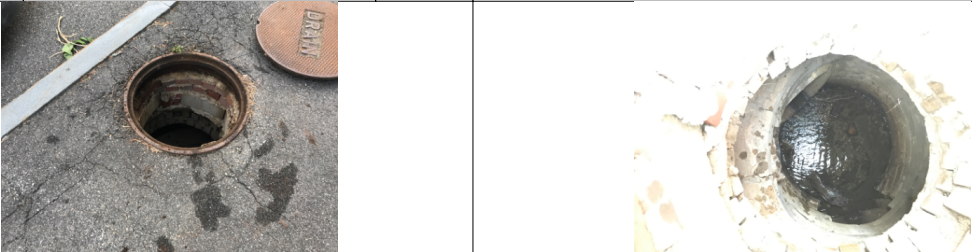
| SECTION 1: BACKGROUND DATA | | | | |
|---|---|--|---|---|
| Street Name/Structure Location: | FOREST ACRES DR | | | |

| SECTION 3A: INLET PIPE NO. 1 PHYSICAL INDICATORS | | | |
|---|---|---|--|
| Asset Damage | None | | |
| Deposits/Stains | Flow Line | | |

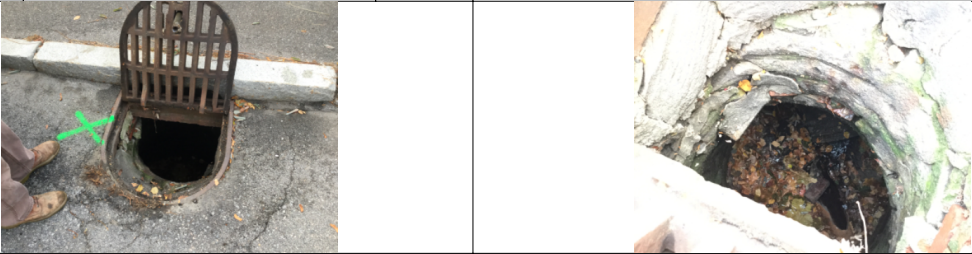
| SECTION 1: BACKGROUND DATA | | | | | | | | | |
|---|---|---|---|---|---|---|---|--|--|
| Asset Damage | | None | | | | | | | |
| Deposits/Stains | | Flow Line | | | | | | | |

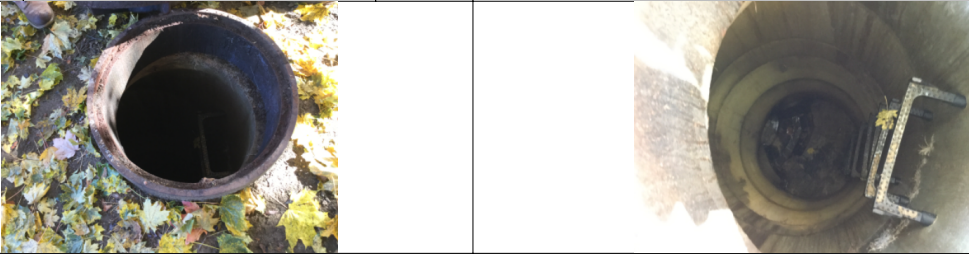
| SECTION 1: BACKGROUND DATA | | | | | | |
|---|---|---|---|---|---|---|
| Asset Damage | None | | | | | |
| Deposits/Stains | Flow Line | | | | | |

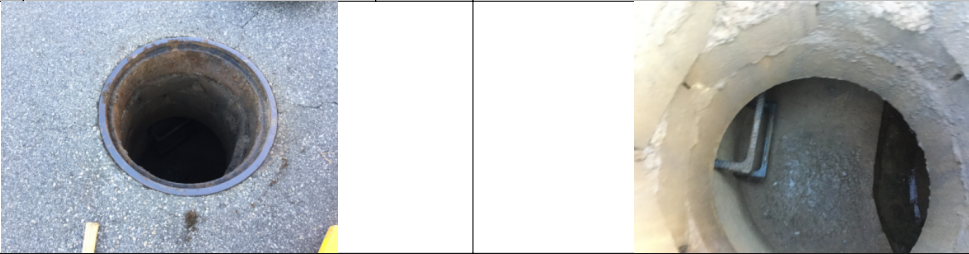
| SECTION 1: BACKGROUND DATA | | | | | | |
|---|---|---|---|---|---|---|
| Asset Damage | None | | | | | |
| Deposits/Stains | Flow Line | | | | | |

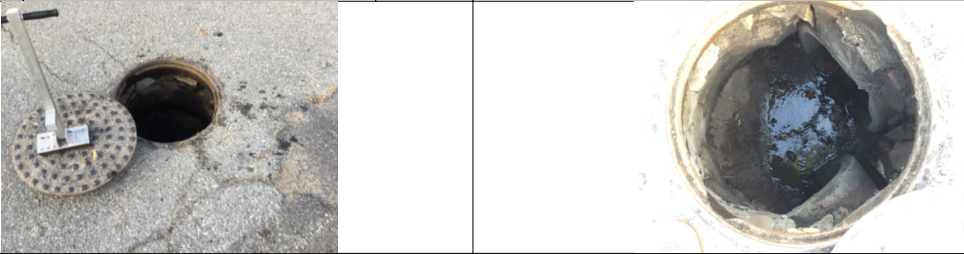
| SECTION 1: BACKGROUND DATA | | | | | | |
|---|---|---|---|---|---|---|
| Asset Damage | Cracking Chipping | | | | | |

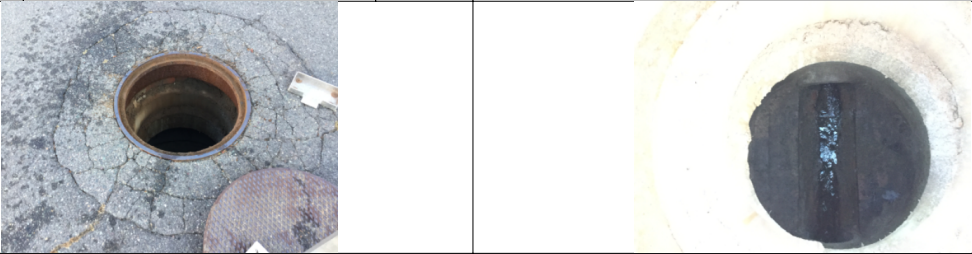
| SECTION 1: BACKGROUND DATA | | | | | | |
|---|---|---|---|---|---|---|
| Asset Damage | None | | | | | |
| Deposits/Stains | Flow Line | | | | | |
