# City of Lincoln – Sewer Master Plan Update

## Final Report

Prepared for:  
City of Lincoln

Prepared by:  
Stantec Consulting Services, Inc.

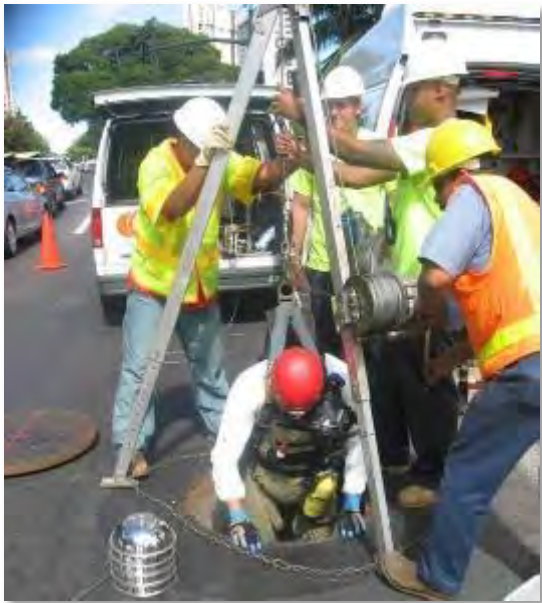
Photo 2-1. Confined Space Entry

A confined space (Photo 2-1) is defined as any space that is large enough and so configured that a person can bodily enter and perform assigned work, has limited or restricted means for entry or exit, and is not designed for continuous employee occupancy. In general, the atmosphere must be constantly monitored for sufficient levels of oxygen (19.5% to 23.5%), the presence of hydrogen sulfide ( $H_2S$ ) gas, carbon monoxide (CO) gas, and lower explosive limit (LEL) levels. A typical confined space entry crew has members with OSHA-defined responsibilities of Entrant, Attendant, and Supervisor. The Entrant is the individual performing the work. He or she is equipped with the necessary personal protective equipment needed to perform the job safely, including a personal four-gas monitor (Photo 2-2). If it is not possible to maintain line-of-sight with the Entrant, then more Entrants are required until line-of-sight can be maintained. The Attendant is responsible for maintaining contact with the Entrants to monitor the atmosphere using another four-gas monitor and maintaining records of all Entrants if there is more than one. The Supervisor is responsible for developing the safe work plan for the job at hand prior to entering.

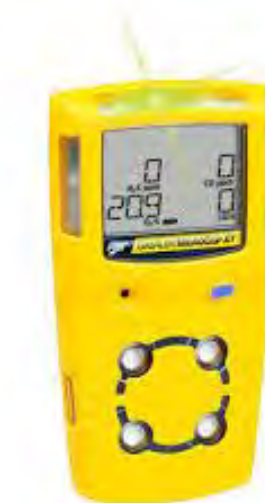
Photo 2-2. Typical Personal Four-Gas Monitor

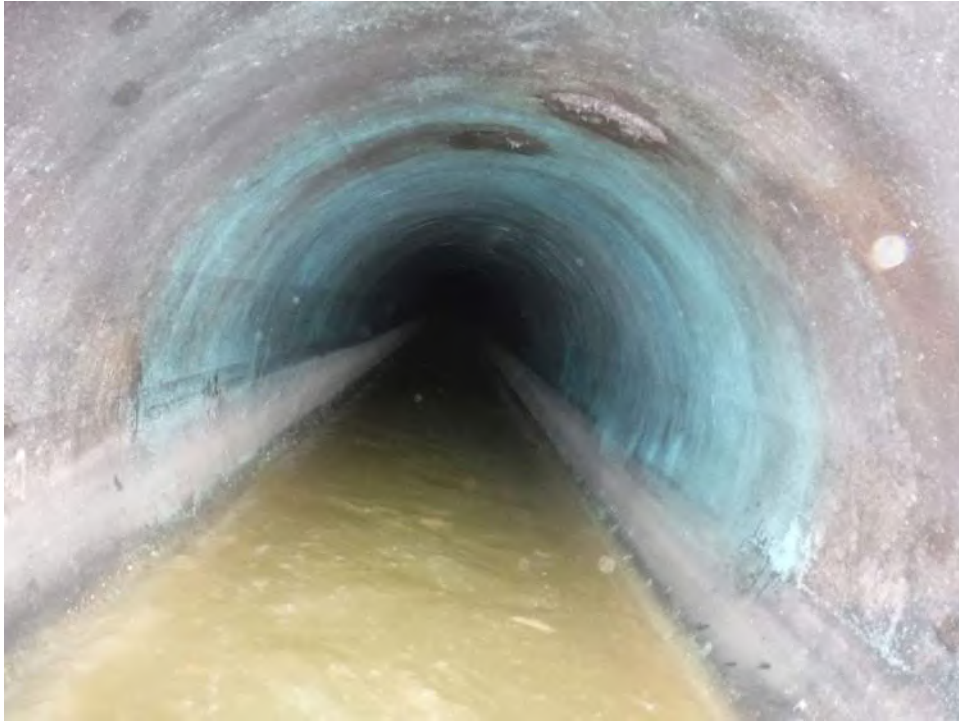
South Effluent Pipe

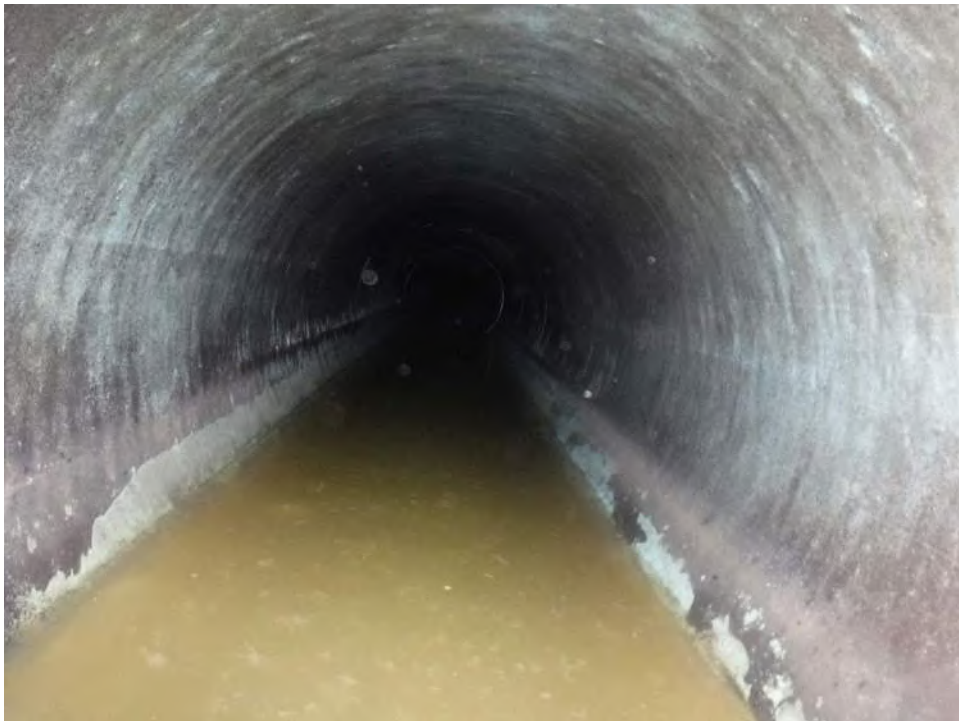
Monitored North Influent Pipe

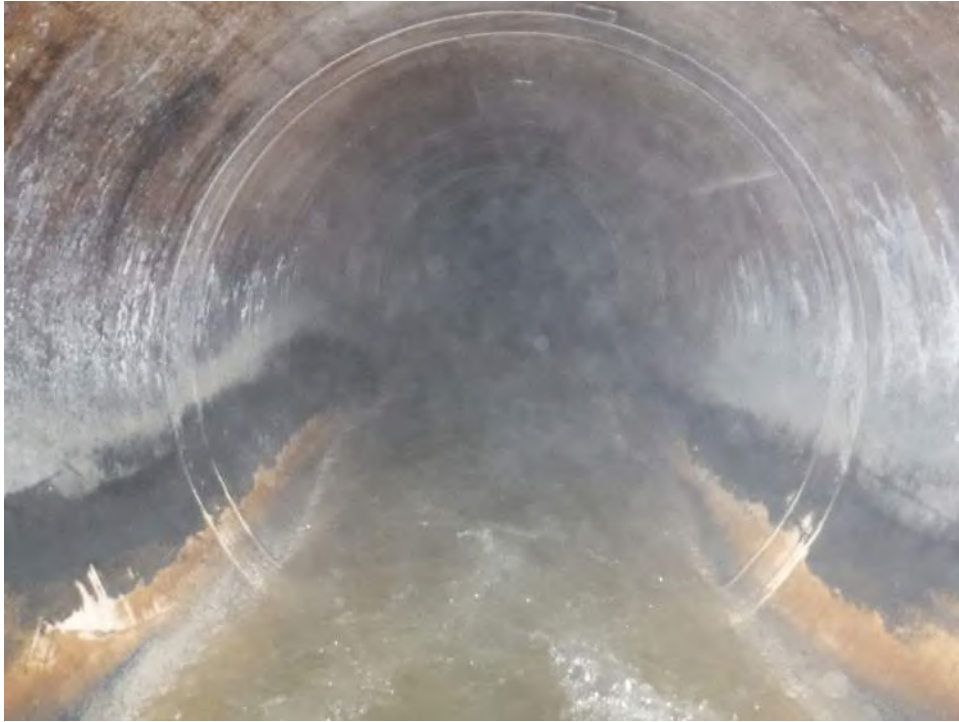
Southwest Effluent Pipe

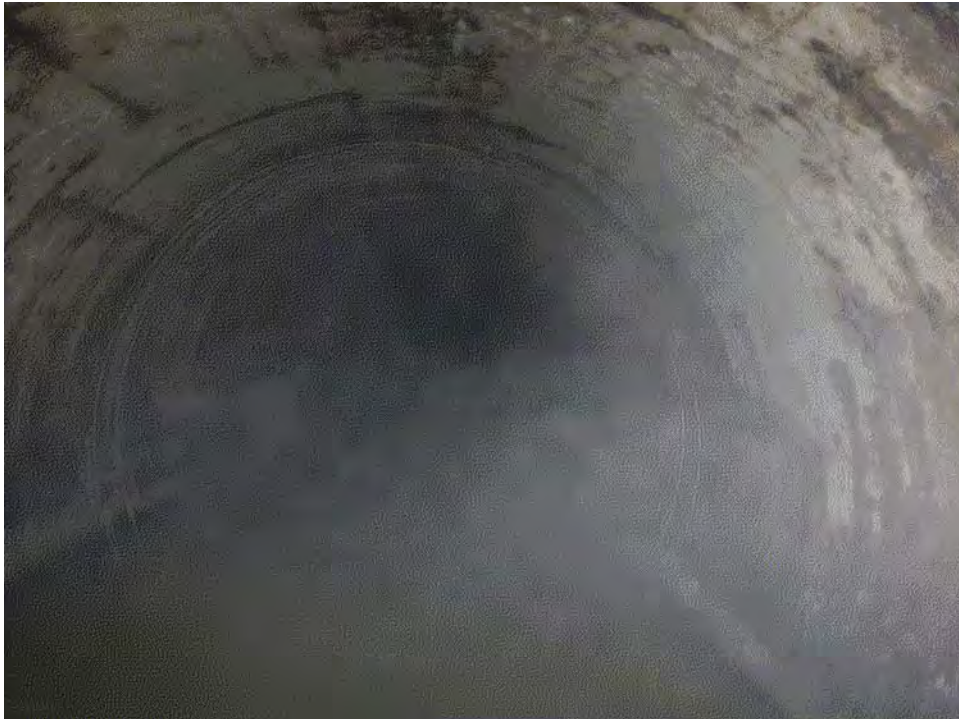
Monitored Northeast Influent Pipe

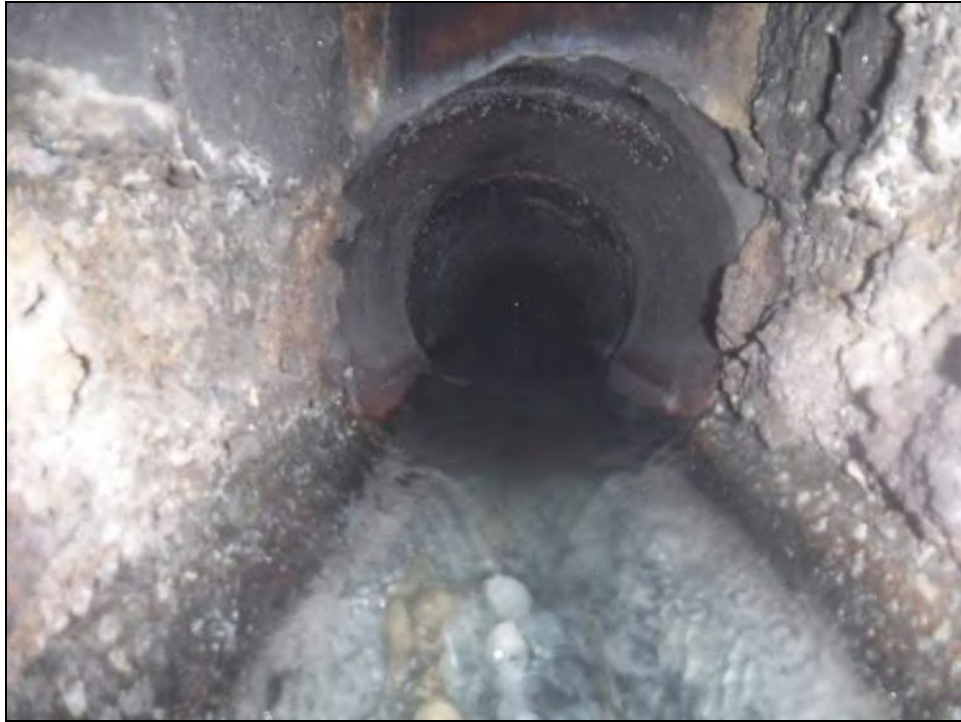
Southeast Influent Pipe

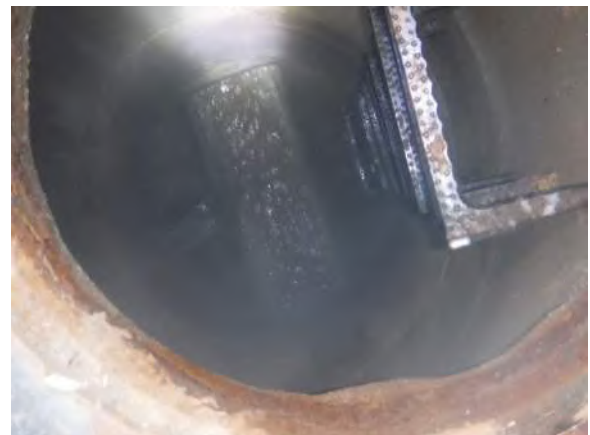
Plan View

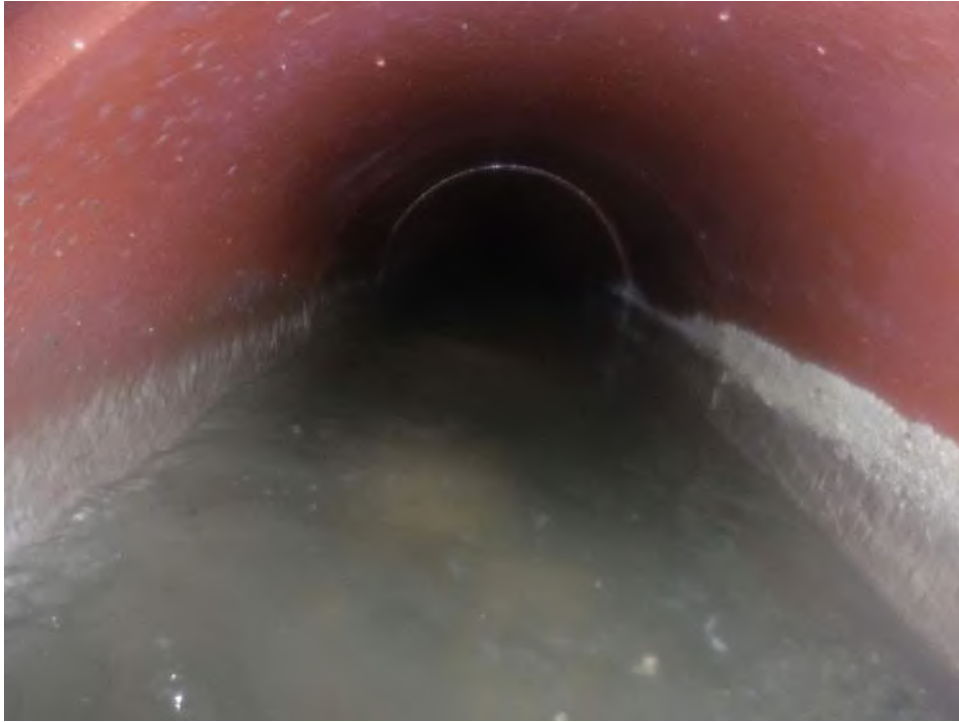
**Southwest Effluent Pipe**

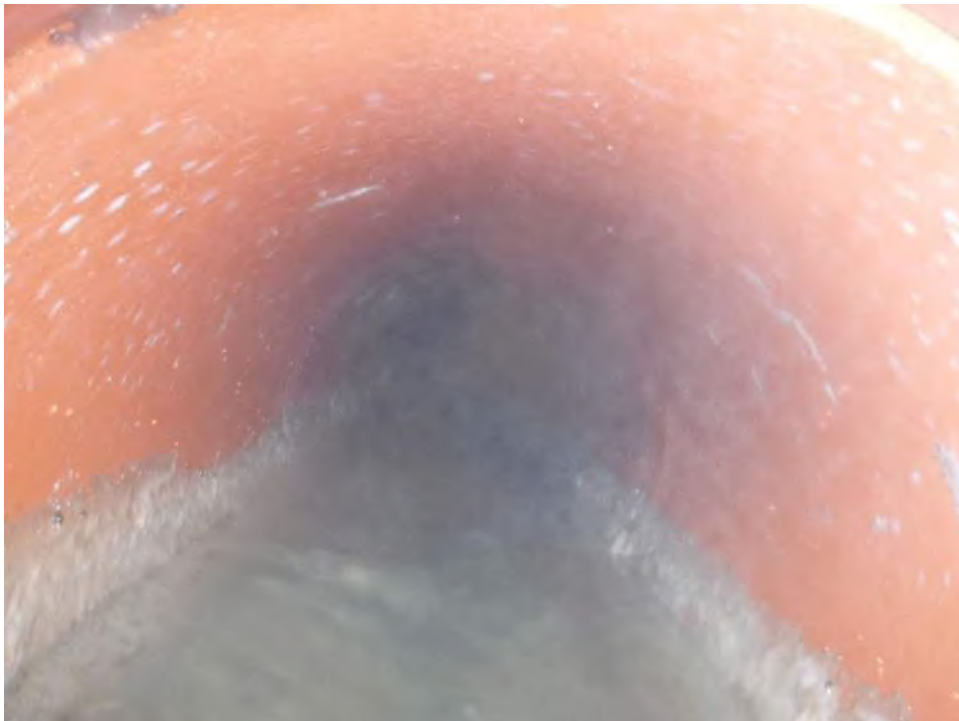
**Monitored Northwest Influent Pipe**

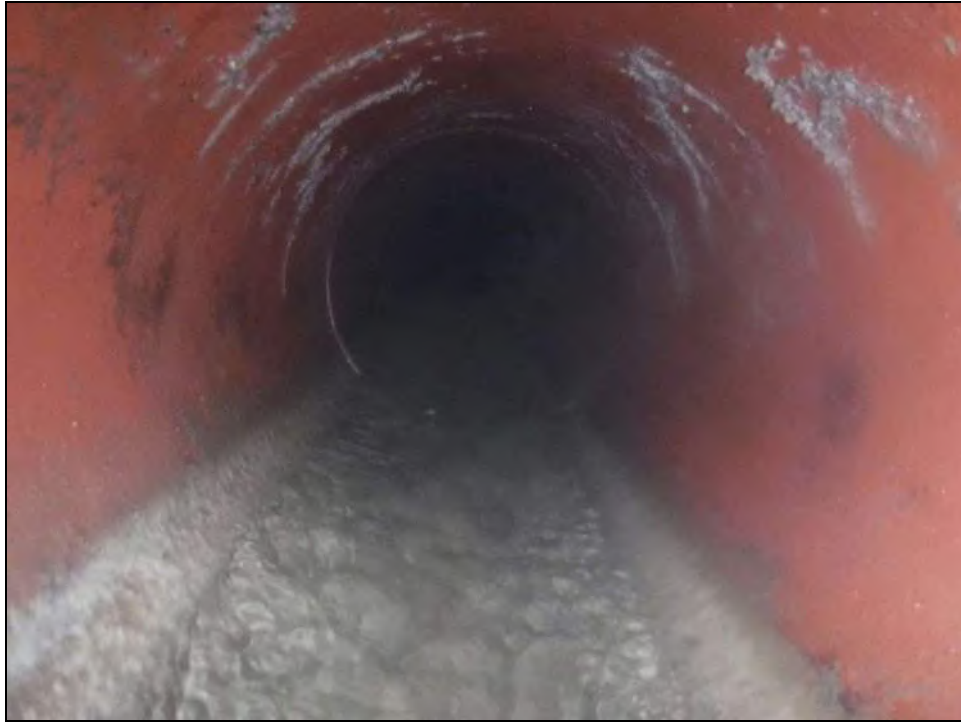
Northeast Influent Pipe

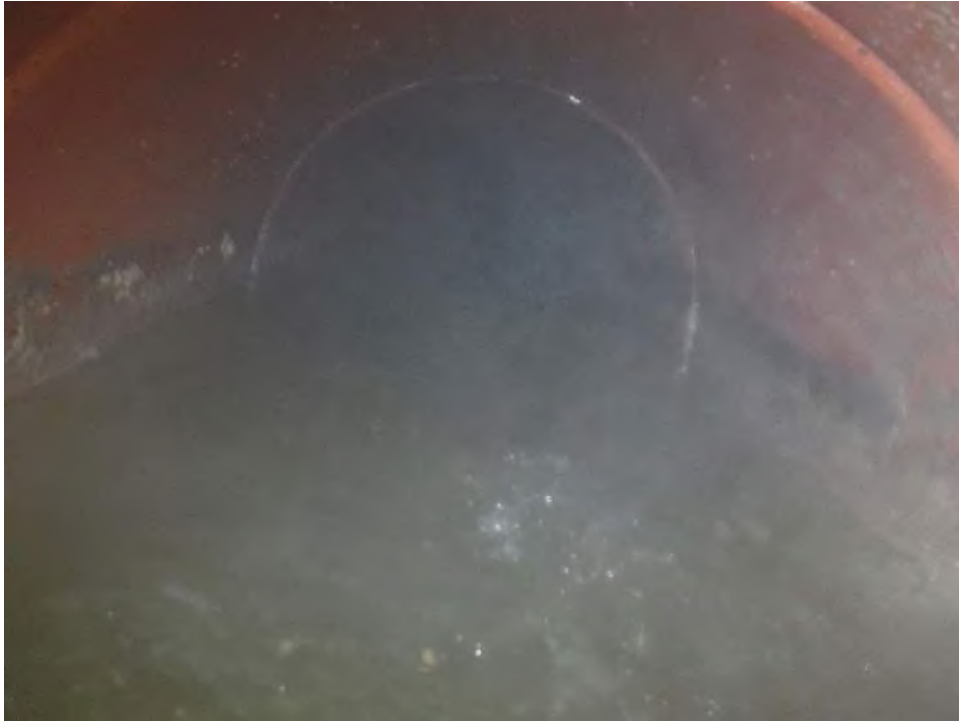
Northwest Effluent Pipe

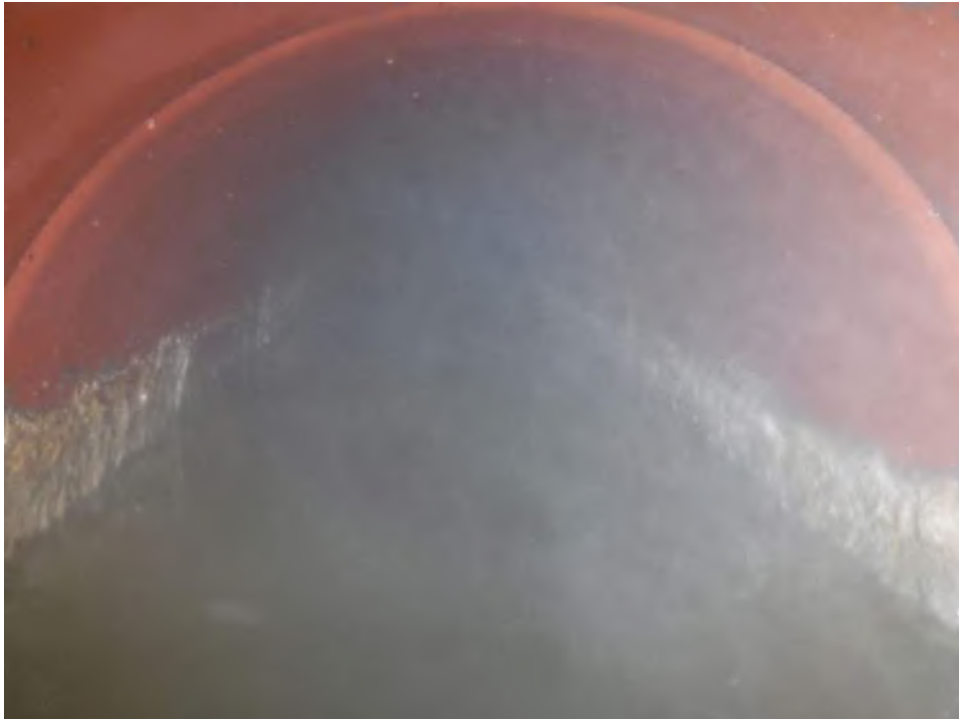
Northeast Influent Pipe

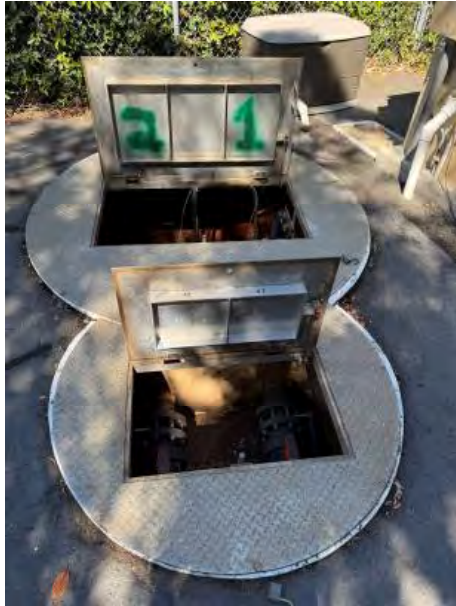
**Access Hatch**

The access hatch of the wet well is in good condition. The access hatch has a latch and spring for accessibility.

Below photographs present the wet well access hatch and the interior of the wet well.

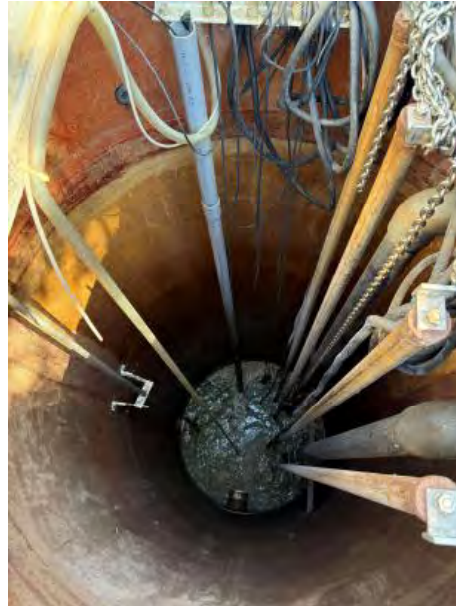
**Wet Well Piping and Coating**

Discharge piping within the wet well is coated and in good condition.

The wet well is not ventilated, which will increase the rate of corrosion but corrosion presently does not appear to be an issue.

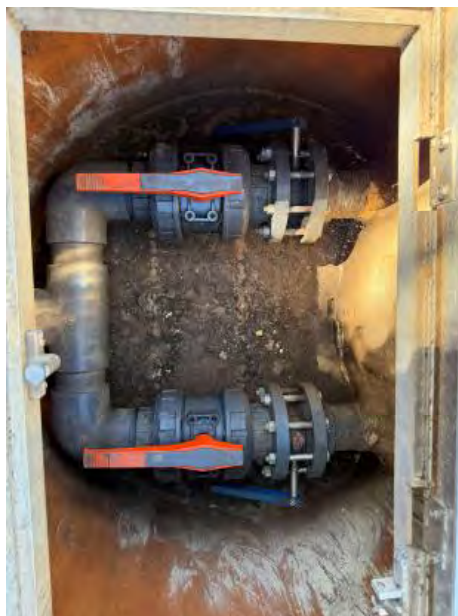
A vault located in the pavement next to the wet well allows access to a pair of valves. The discharge valves and piping within the vault are in good condition.

**Above Ground Vault Piping**

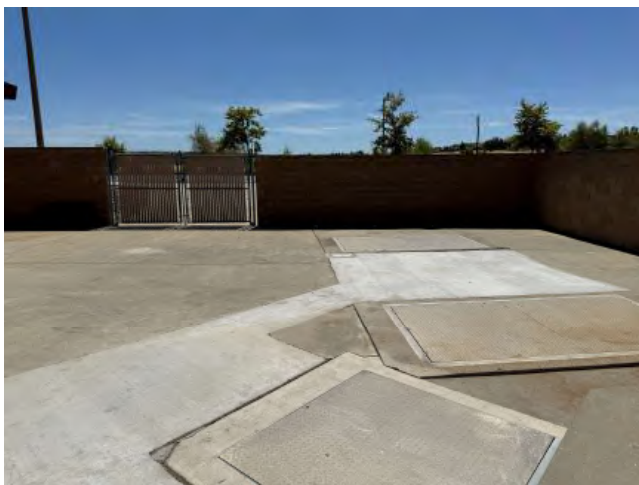
**Access Hatch**

The top slab of the wet well and the access hatches are in good condition. The interior walls of the wet wells are coated and in good condition.

The below photographs present the corroded access hatch and the interior of the wet well.

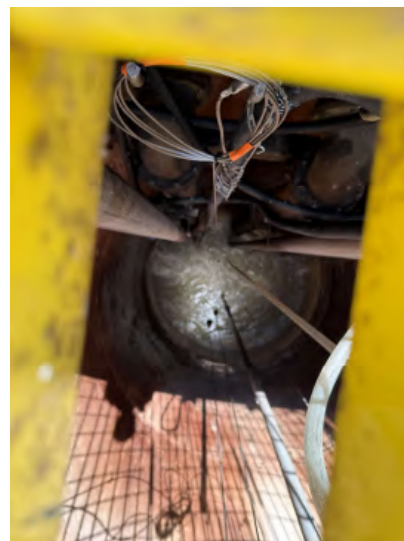
**Wet Well, Piping and Valve Coating**

Discharge piping within the wet well is in good condition but the coating is peeling. The wet well is ventilated. Discharge piping and valves in the valve vault were in good condition.

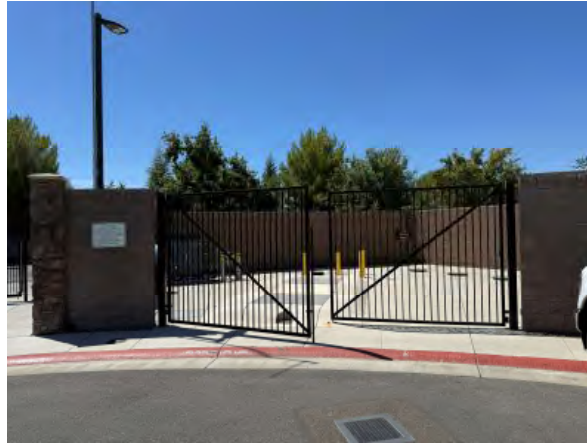
The lift station is located within a masonry-walled area within a residential subdivision on Nisenan Valley Drive. Access is from the road through a locked gate. There is fall protection in the wet well and valve vault. There are no security cameras but there is sufficient lighting.

**General Site Layout**

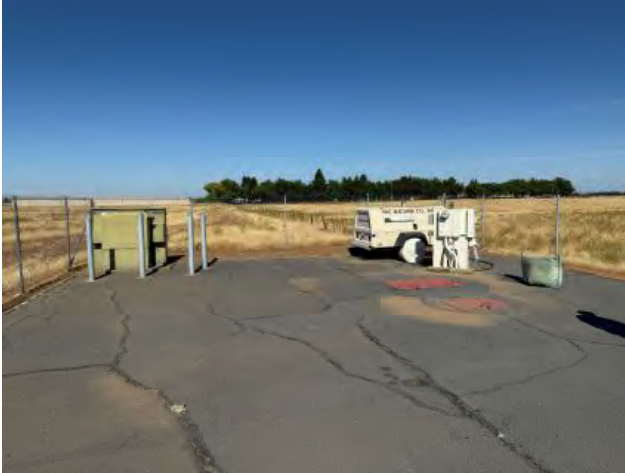
Flightline Lift Station is located at the northern termination of Aviation Drive. The lift station consists of a circular wet well constructed in 1985 and has two (2) 60HP submersible pumps with an unknown capacity.

**General Site Layout**

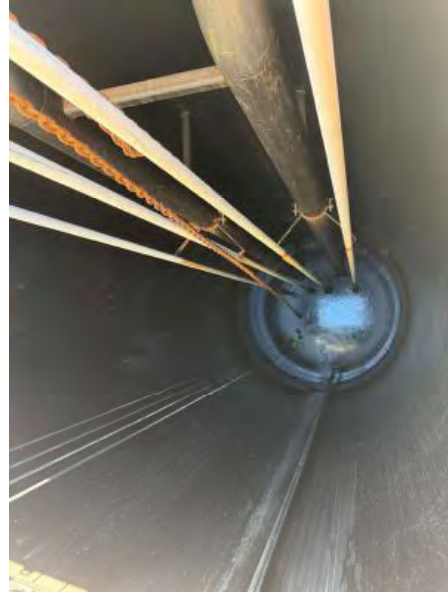
**Wet Well and Piping**

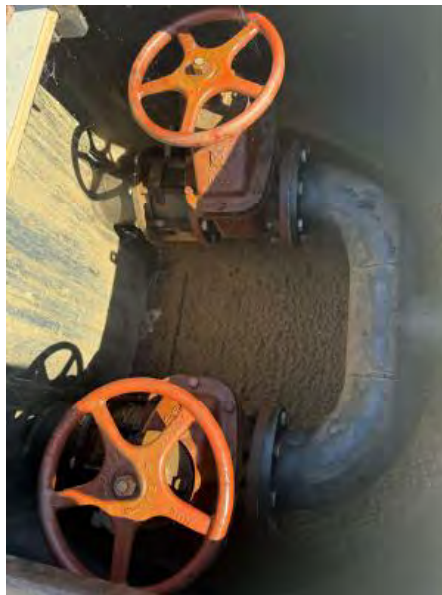
A valve vault located next to the wet well allows access to discharge valves. The valves and piping within the vault are coated and in good condition.

**Above Grade Vault**

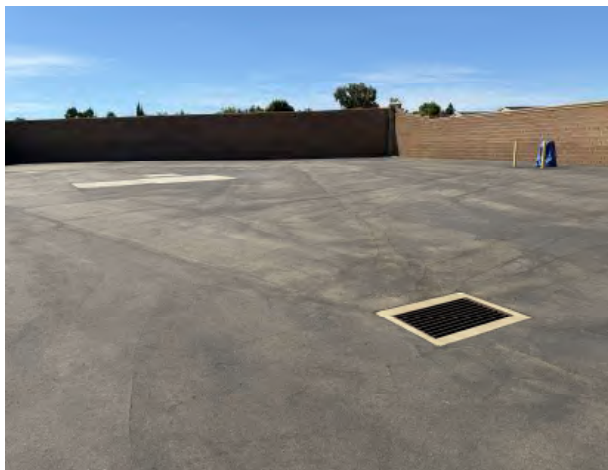
Independence Lift Station is located at 2873 Delegate Drive in a residential subdivision. The lift station consists of a circular wet well in a paved and walled area with an adjacent valve vault. The lift station was constructed in 2020 and has a rated capacity of 485 gpm with two (2) 15HP Flygt submersible pumps.

**Site**

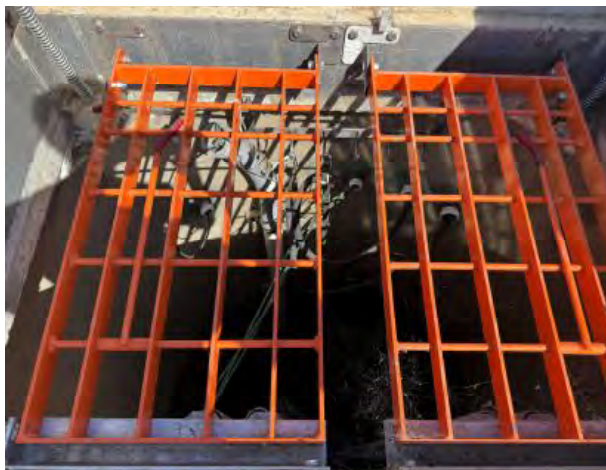
**Wetwell**

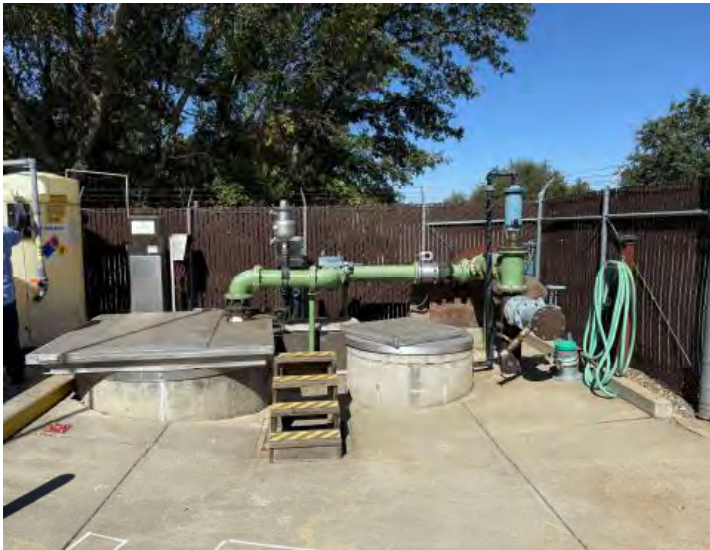
**Site Layout**

Nicolaus Road Lift Station is located at 2885 Nicolaus Road in a fenced area on the shoulder of the road. The lift station consists of two circular wet wells and above ground discharge piping. The lift station was constructed in 1985 and has a rated capacity of 2,340 gpm with two (2) 60HP Flygt submersible pumps in the large wet well and one (1) 20HP Flygt submersible pump in the small wetwell. The small wet well is used as a standby backup.

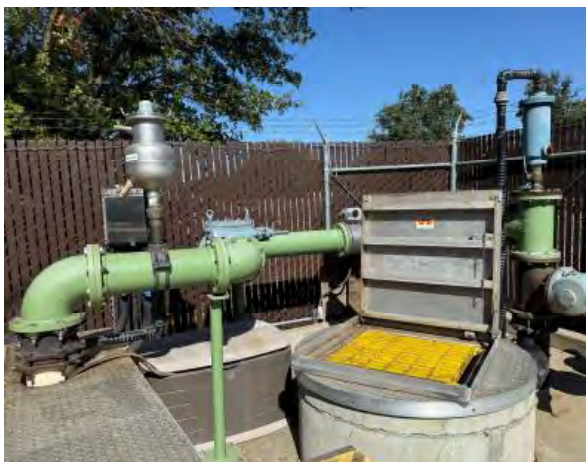
**Above Ground Piping**

Discharge piping and valves located above ground are coated and in good condition. A valve vault contains flow meters and associated valves that are coated and in good condition.

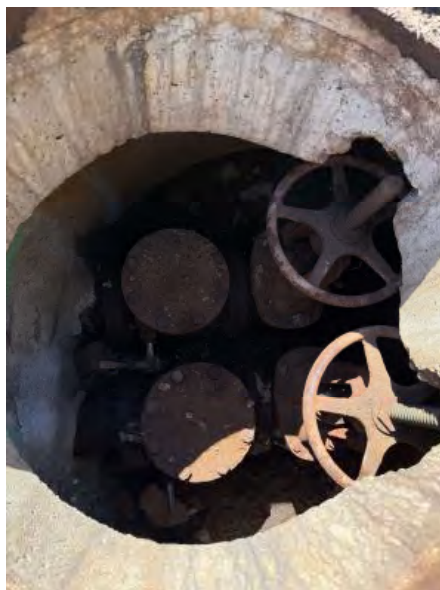
**Valve Vault**

The discharge piping within the wet well is not coated and is corroded. The wet well is not ventilated and has no odor control system, which has likely increased the rate of piping corrosion. The valves and discharge piping in the valve vault are significantly corroded and in need of replacement.

A valve vault located next to the wet well allows access to discharge valves through an unlocked manhole. The valves and piping within the vault are in very poor condition and in need of replacement.

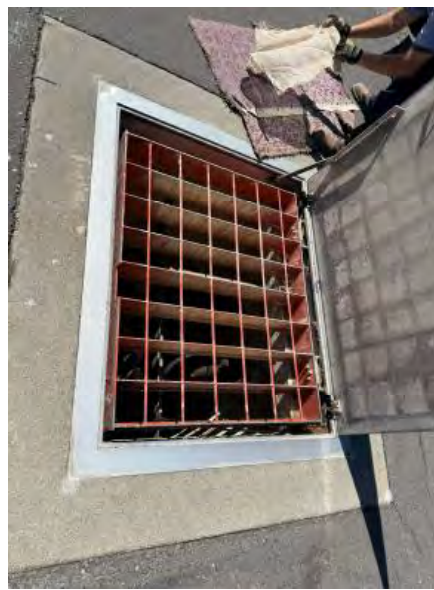
**Wet Well Hatch**

The top slab and the access hatch are in good condition. The interior wall of the wet well is coated but has some corrosion.

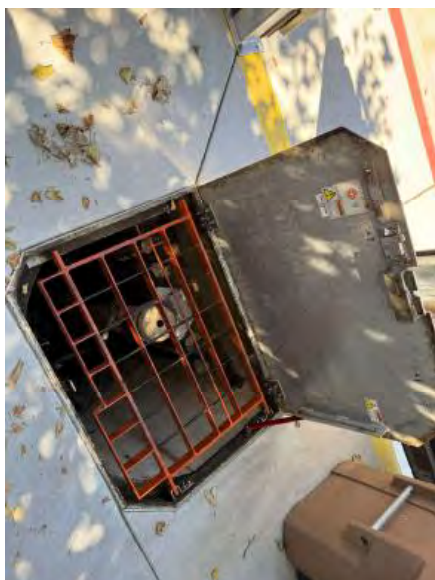
**Access Hatch**

The top slab and access hatch are in good condition. The interior wall of the wet well is in good condition but is not coated.

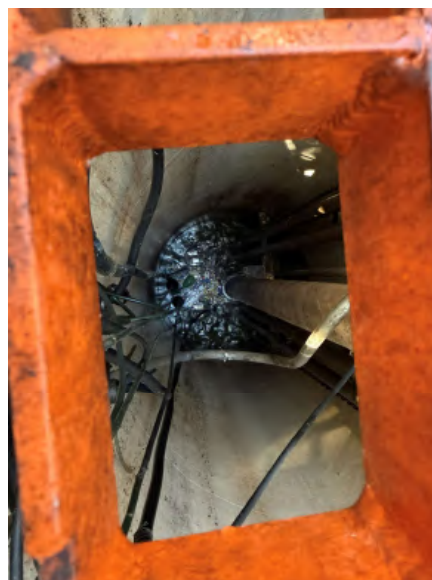
**Wet Well**

The discharge piping within the wet well is coated and in fair condition. The wet well is not ventilated and has no odor control system, which has likely increased the rate of piping corrosion.

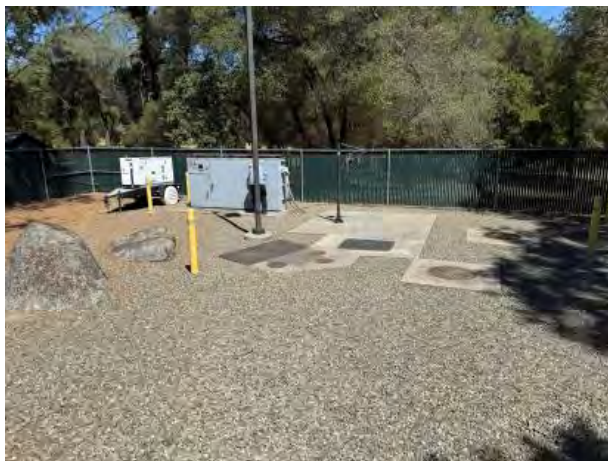
**General Site Layout**

Village 19 Lift Station is located at 3679 Camino Cielo at the end of the road. The lift station consists of a circular wet well and discharge piping vault. It was constructed in 2005 and has two (2) 4HP Flygt submersible pumps.

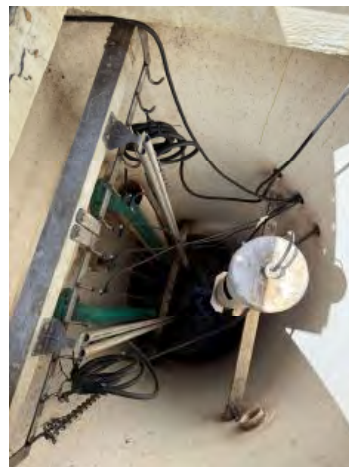
**Wet Well**

The discharge piping within the wet well is coated and in good condition. The wet well has an odor control system but it has not been in recent use.

The top slab and access hatch are in good condition. The interior wall of the wet well is lined and in good condition.

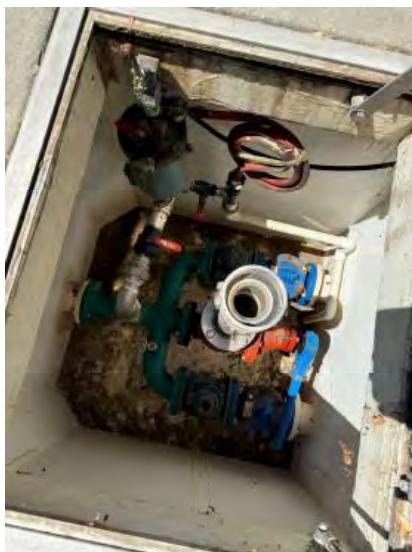
**Discharge Piping Vault**

A vault located next to the wet well allows access to discharge valves that are coated and in good condition.
